## Hess Lake Muck Monitoring 2017

For the last two years, Savin Lake Services has been collecting muck thickness measurements in two coves on the south side of Hess Lake. The reason for this is to determine the efficacy of bacterial augmentation treatments in both coves and the affect the aeration system is having in the larger cove in combination with the treatments. For each of the last two years Savin Lake Service has measured the thickness (as depth) of the muck three different times, once in the spring, the summer, and the fall.

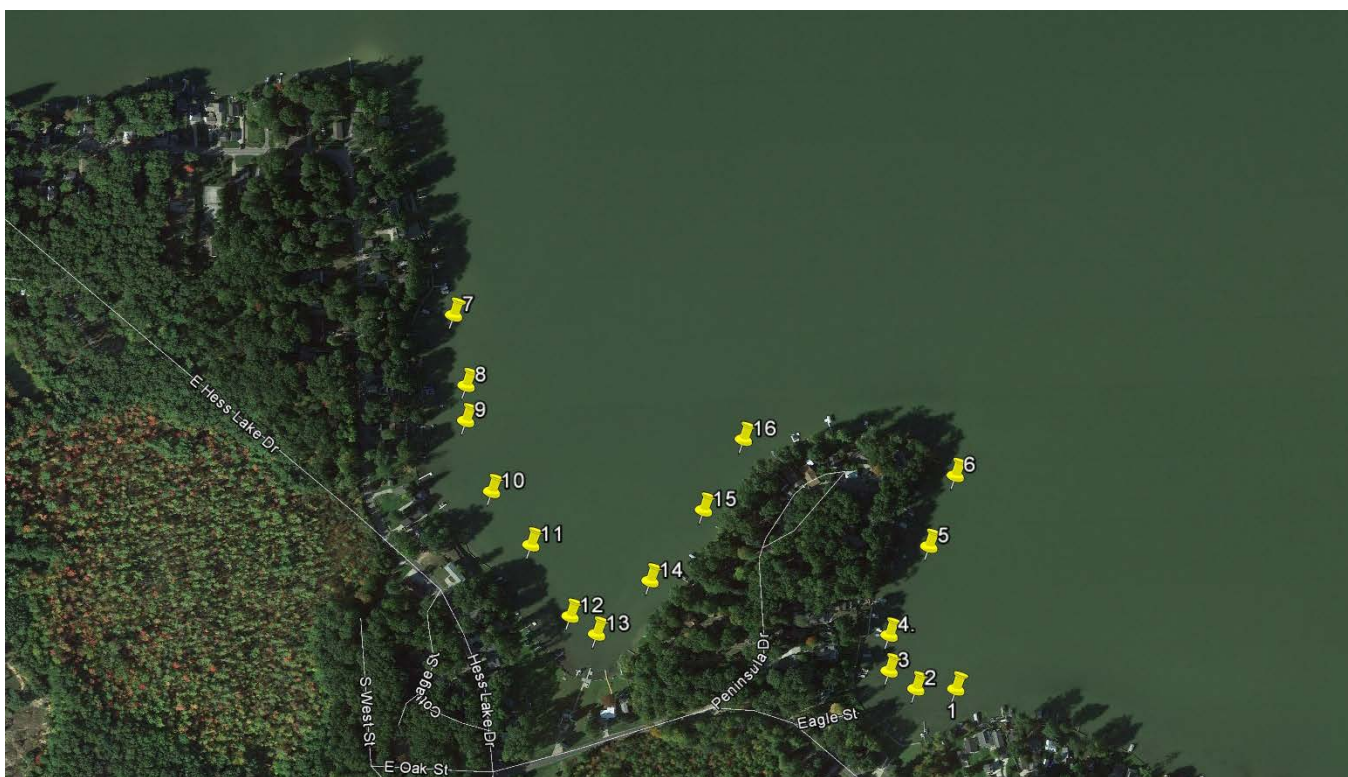
## Monitoring Location Map

The next page will show the muck monitoring results, as well as the map where each site location is found.
