Hess Lake Muck Monitoring 2018

Muck Measurement Results

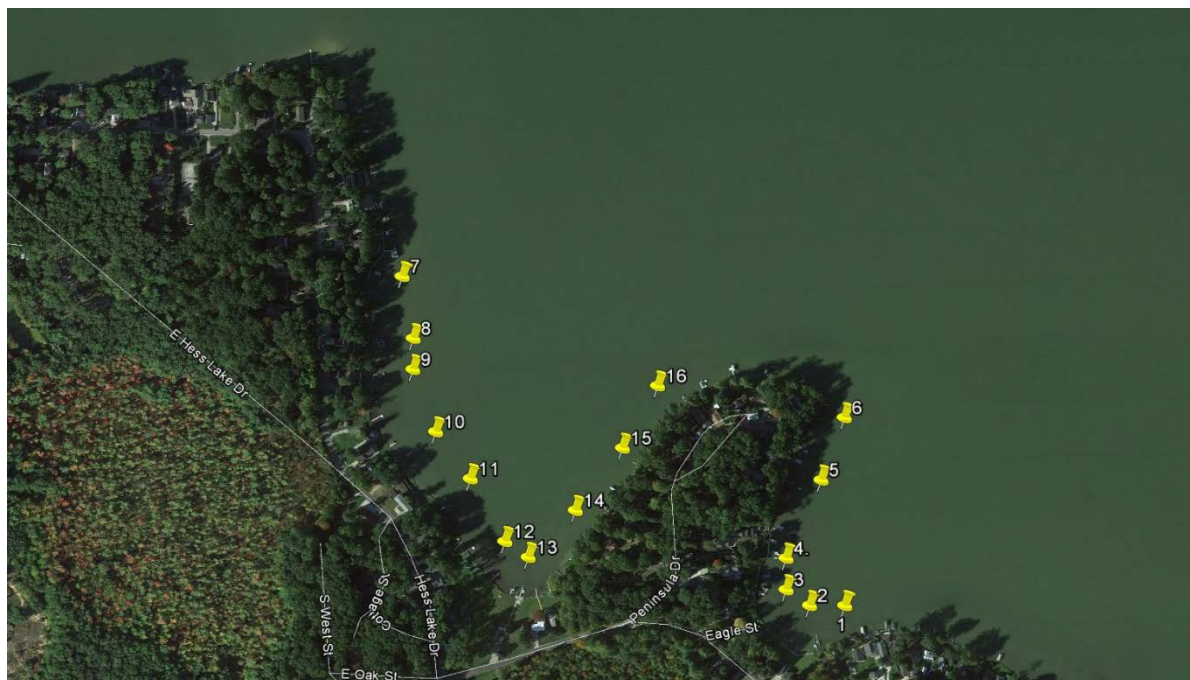
Monitoring Location Map

The next page will show the muck monitoring results, as well as the map where each site location is found.
